Cosumnes Community Services District

Camden Weir Project Overview

March 5, 2009 Pre-Application Meeting for Sacramento Region

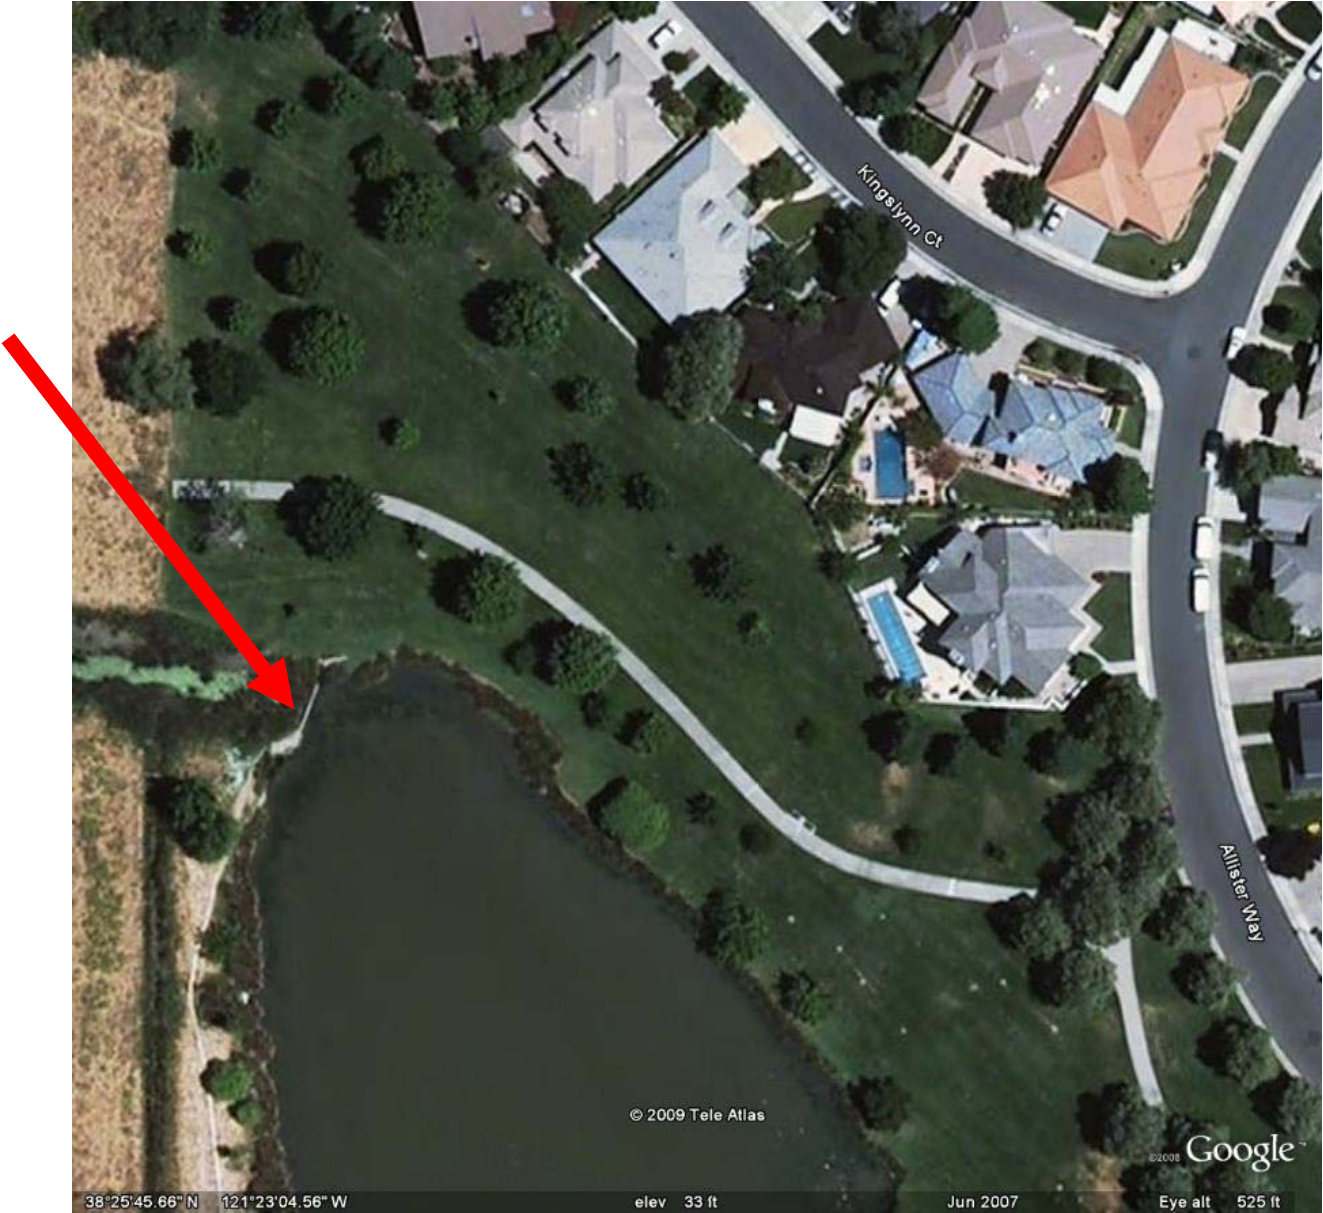
Camden Weir

The CCSD weir is a concrete structure approximately 30 inches tall and 30 feet long. The weir was constructed in 1994 in an agreement with the California Department of Fish and Game (DFG). The DFG was closing the fish hatchery at Bond Road and Elk Grove Florin Road, but had a well on-site. The well provided:

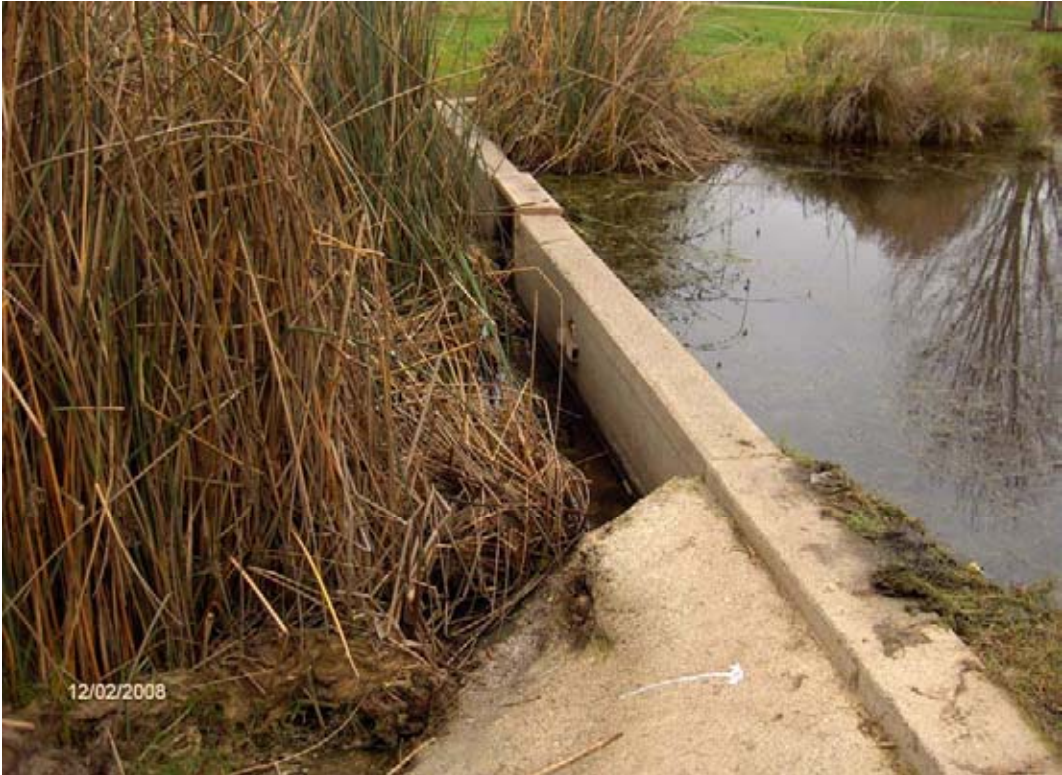
The weir is leaking around the sides and underneath the structure. The resulting water flow is causing water to pond in large areas downstream (on the west side of the weir). These ponds have become a breeding ground for mosquitoes. Sacramento-Yolo Mosquito Vector Control (Vector Control) is using up considerable resources spraying for mosquitoes in this area. The mosquito issue is so severe that it could require aerial spraying in the future. Vector Control considers this a public safety issue, and has requested CCSD repair the weir.

Photo of Camden Weir looking north. Pond on right side of photo. Downstream on left side.

CCSD is developing a plan to repair the weir. This may include:

- extending the weir further onto the creek banks
- reinforcing the existing structure
- replacing the structure

The general course of action would be to dewater around the weir and repair/replace the structure as needed. CCSD wants input from the USACE/USFWS/DFG regarding acceptable construction methods before proceeding to develop a specific plan.

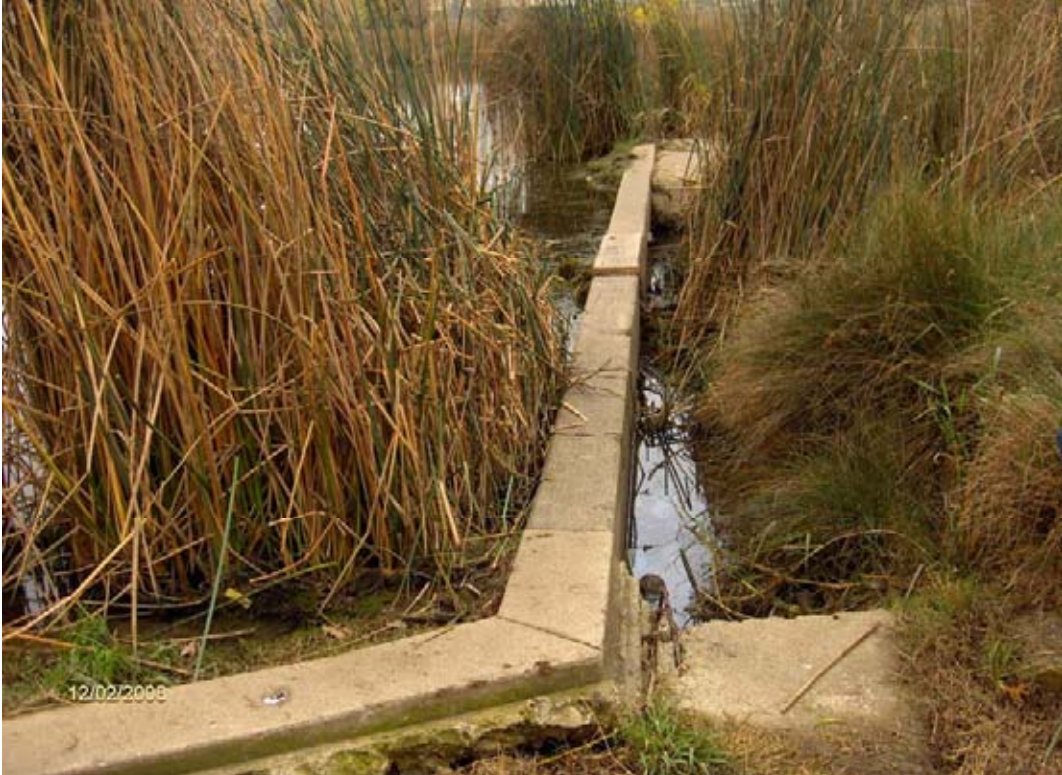
Photo of Camden Weir looking south. Pond on left side of photo. Downstream on right side.
